INSPECTION REPORT

Report Number
14213

**3929 Arthur St. NE
Columbia Heights, Minnesota
55421**

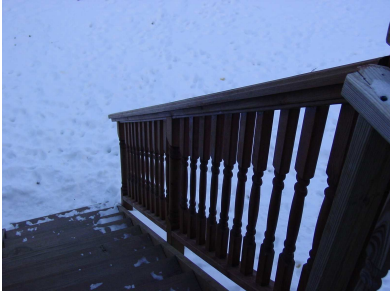
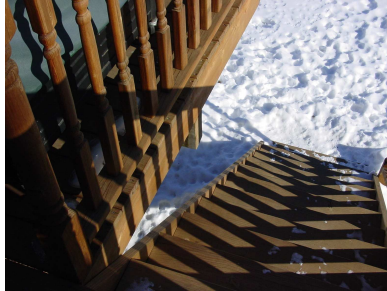
1

LOCATION: Deck

CONDITION: Handrails are generally unsafe. (Multiple deficiencies)

IMPACT/CONSEQUENCES: The primary function of handrailings is to assist people in traversing the stairs and reduce the potential of fall injuries on stairs. There is indication of poor design, construction, or maintenance, such that the handrailings do not appear to be in a condition that meets its intended function of protecting people from the risk of injury. Failure to correct handrailing deficiencies is a safety issue, and in some cases may have legal consequences where a person is injured as a result of neglecting to provide adequate safety provisions on the stairs.

RECOMMENDED ACTION: Safety Concern | Repair or Replace

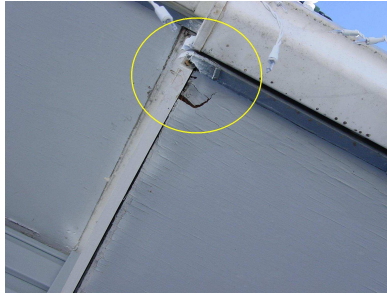
2

**LOCATION:** Exterior right side of house section**CONDITION:** Soffit is deteriorated**EXPLANATION:** The soffit is observed to be in a deteriorated condition. Repairs are required to restore the soffits.**IMPACT/CONSEQUENCES:** The soffit areas at roof edges are vulnerable to water infiltration and pest intrusion if not adequately sealed. Adding/restoring soffits in the noted area is recommended.**RECOMMENDED ACTION:** Repair

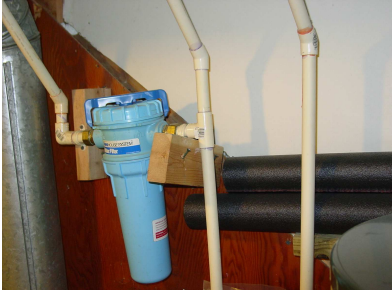
-
- 1

**LOCATION:** Utility Room
CONDITION: Water pipes not adequately supported
EXPLANATION: Proper support of water distribution piping is required to reduce the risk of damage. Piping should be sufficiently supported to carry the weight of both the pipe and its water load, and to minimize stress on fittings.
IMPACT/CONSEQUENCES: Pipes that are not properly supported are susceptible to damage. Failure to properly support pipes may lead to pipe or joint rupture.
RECOMMENDED ACTION: Repair
-

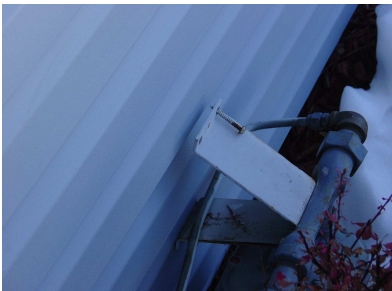
- 2

**LOCATION:** Exterior
CONDITION: Gas meter not adequately supported
EXPLANATION: Gas meter should be adequately supported to prevent placing stress on fittings and connectors. The intent of support is to carry the weight of the meter, so not to rigidly constrain the pipe, such that undo stress is not placed on joints and connectors.
IMPACT/CONSEQUENCES: Gas meters not properly supported will place strain on fittings and connectors, which can result in gas leaks. Providing adequate support should be considered a safety issue requiring immediate attention.
RECOMMENDED ACTION: Repair
-

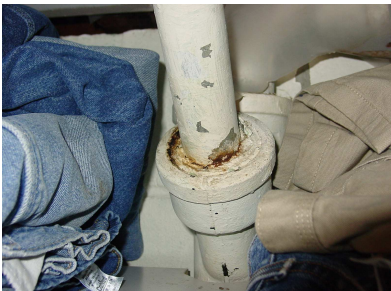
- 3

**LOCATION:** Basement
CONDITION: Cast iron piping is observed in the drainage system
EXPLANATION: Cast iron drainage piping should be closely monitored for damage and deterioration. Systems with horizontal sections of cast iron pipes are more prone to blockage. Fittings in cast iron system are prone to rust and leakage. Impacts can fracture this form of piping.
IMPACT/CONSEQUENCES: Cast iron piping is subject to performance issues, including tendency for blockage and vulnerability to physical deterioration. Planning for replacement is often a prudent course of action.
RECOMMENDED ACTION: Monitor
-

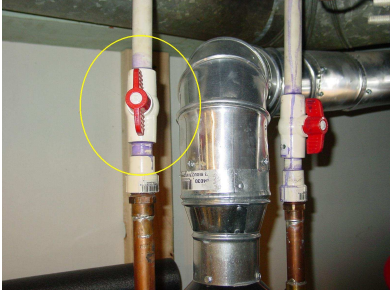
4

**LOCATION:** Utility Room**CONDITION:** Water tank shut-off valve installed on hot side.**EXPLANATION:** This water heater has a shut off installed on the hot side as well as the cold side.**IMPACT/CONSEQUENCES:** A water heater should never have a shut off valve installed on the hot water outlet water line. A shut off valve should only be installed on the cold water side. If a valve is on both lines, and someone turns them off while the heater is on, and the Temperature / Pressure Relief Valve fails this could produce an explosion causing severe damage. This configuration is a SAFETY issue.**RECOMMENDED ACTION:** Install**OBSERVATIONS & SUGGESTIONS:**

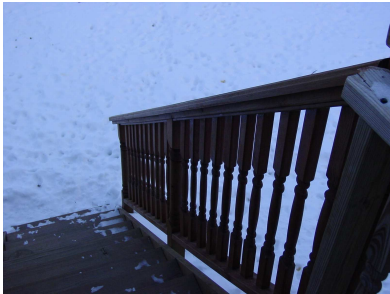
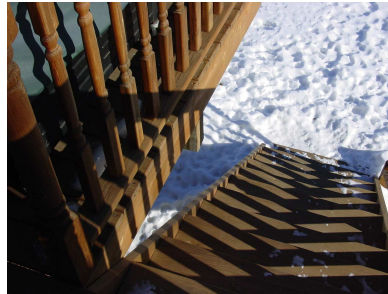
1

LOCATION: Deck

CONDITION: Handrails are generally unsafe. (Multiple deficiencies)

IMPACT/CONSEQUENCES: The primary function of handrailings is to assist people in traversing the stairs and reduce the potential of fall injuries on stairs. There is indication of poor design, construction, or maintenance, such that the handrailings do not appear to be in a condition that meets its intended function of protecting people from the risk of injury. Failure to correct handrailing deficiencies is a safety issue, and in some cases may have legal consequences where a person is injured as a result of neglecting to provide adequate safety provisions on the stairs.

RECOMMENDED ACTION: Safety Concern | Repair or Replace

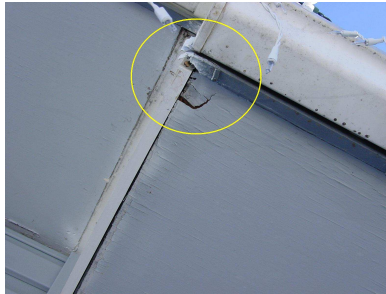
2

LOCATION: Exterior right side of house section

CONDITION: Soffit is deteriorated

EXPLANATION: The soffit is observed to be in a deteriorated condition. Repairs are required to restore the soffits.

IMPACT/CONSEQUENCES: The soffit areas at roof edges are vulnerable to water infiltration and pest intrusion if not adequately sealed. Adding/restoring soffits in the noted area is recommended.

RECOMMENDED ACTION: Repair

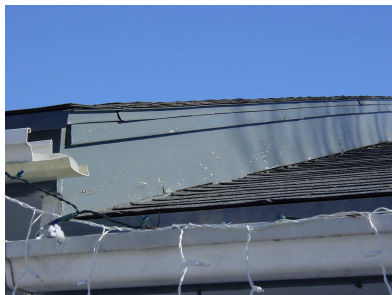
3

LOCATION: Exterior right side of house section

CONDITION: Fascia requires painting

EXPLANATION: The paint on the fascia's is observed to be deteriorated. Paint is required to preserve the fascia's from weather damage.

IMPACT/CONSEQUENCES: Deteriorated paint on wood fascia's will result in rot and damage to the wood. Failure to provide periodic painting as part of normal preventative maintenance actions will result in deterioration of the fascia.

RECOMMENDED ACTION: Repair

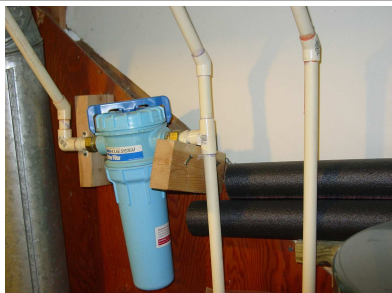
5

LOCATION: Utility Room

CONDITION: Water pipes not adequately supported

EXPLANATION: Proper support of water distribution piping is required to reduce the risk of damage. Piping should be sufficiently supported to carry the weight of both the pipe and its water load, and to minimize stress on fittings.

IMPACT/CONSEQUENCES: Pipes that are not properly supported are susceptible to damage. Failure to properly support pipes may lead to pipe or joint rupture.

RECOMMENDED ACTION: Repair

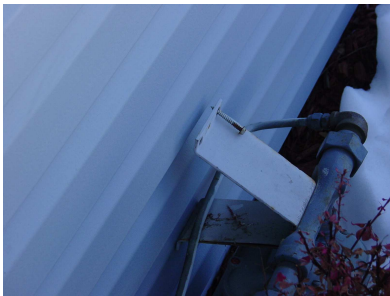
6

**LOCATION:** Exterior**CONDITION:** Gas meter not adequately supported**EXPLANATION:** Gas meter should be adequately supported to prevent placing stress on fittings and connectors. The intent of support is to carry the weight of the meter, so not to rigidly constrain the pipe, such that undo stress is not placed on joints and connectors.**IMPACT/CONSEQUENCES:** Gas meters not properly supported will place strain on fittings and connectors, which can result in gas leaks. Providing adequate support should be considered a safety issue requiring immediate attention.**RECOMMENDED ACTION:** Repair

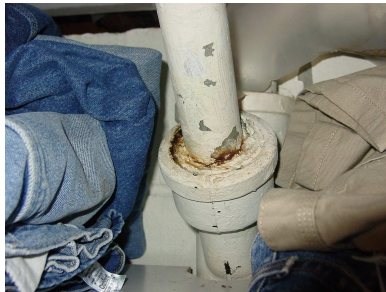
8

**LOCATION:** Basement**CONDITION:** Cast iron piping is observed in the drainage system**EXPLANATION:** Cast iron drainage piping should be closely monitored for damage and deterioration. Systems with horizontal sections of cast iron pipes are more prone to blockage. Fittings in cast iron system are prone to rust and leakage. Impacts can fracture this form of piping.**IMPACT/CONSEQUENCES:** Cast iron piping is subject to performance issues, including tendency for blockage and vulnerability to physical deterioration. Planning for replacement is often a prudent course of action.**RECOMMENDED ACTION:** Monitor

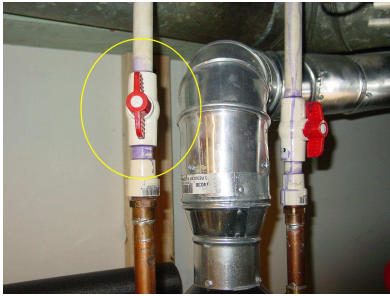
9

**LOCATION:** Utility Room**CONDITION:** Water tank shut-off valve installed on hot side.**EXPLANATION:** This water heater has a shut off installed on the hot side as well as the cold side.**IMPACT/CONSEQUENCES:** A water heater should never have a shut off valve installed on the hot water outlet water line. A shut off valve should only be installed on the cold water side. If a valve is on both lines, and someone turns them off while the heater is on, and the Temperature / Pressure Relief Valve fails this could produce an explosion causing severe damage. This configuration is a SAFETY issue.**RECOMMENDED ACTION:** Install
